CRREL REPORT 89-10

*Definition of research needs to address
airport pavement distress in cold regions*

11. TITLE (Include Security Classification) Definition of Research Needs to Address Airport Pavement Distress in Cold Regions.				
12. PERSONAL AUTHOR(S) Ted S. Vinson, Richard L. Berg, Irene Zomeran and Wilbur Haas				
13a. TYPE OF REPORT Final	13b. TIME COVERED FROM _____ TO _____	14. DATE OF REPORT (Year, Month, Day) May 1989	15. PAGE COUNT 147

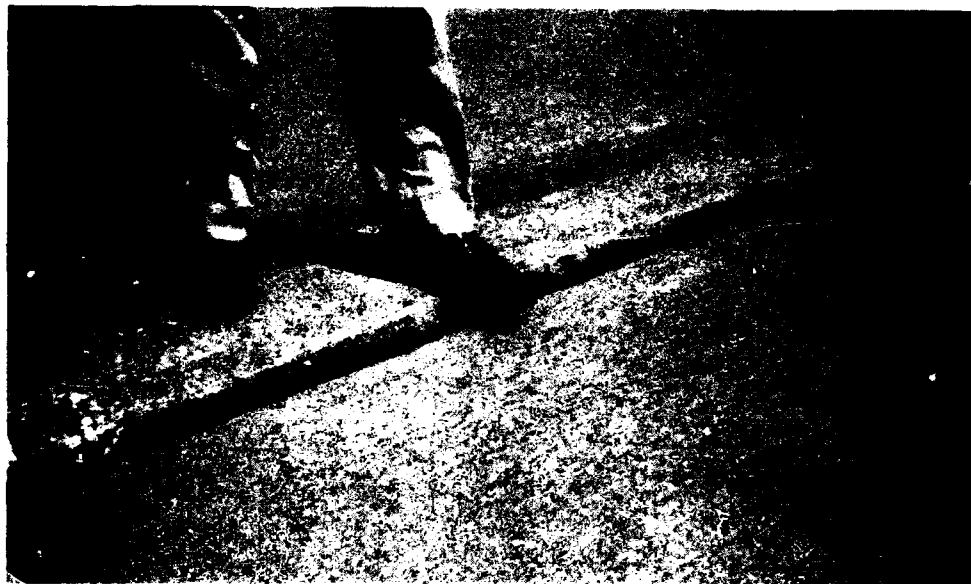
Figure 33. Distortion of PCC pavement surface caused by frost heave.

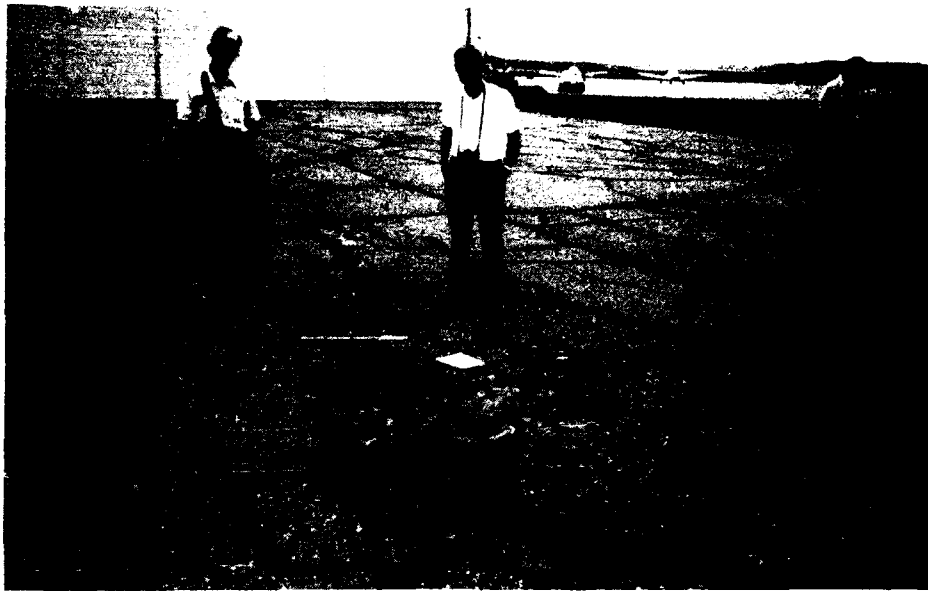
Figure 43. Disintegration in an AC parking apron.
